# Study on Implementation of Risk based Inspection using FMEA-FTA Method on Ro-Ro Ship Bastiong-Sofifi Route

Keywords: Risk Based Inspection, FMEA-FTA, Ro-Ro Ship

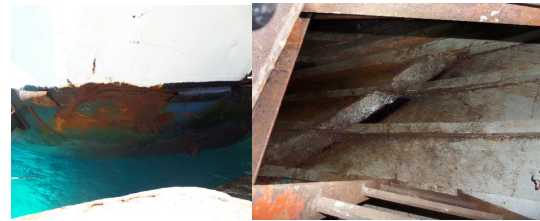
Corrosion occurs in the reinforcement and outer plates on the side hull. In Fig 2 it can be seen that the ship is experiencing corrosion on the side of the hull and its reinforcement. Corrosion of the hulls (inside) occurs due to seepage of water and air from the outside. This seepage can occur because of a crack on the side hull (Figure 2a).

Figure 2: (a) side hull (b) side stringer hull.

Crack on the side hull can occur due to corrosion that forms naturally due to interaction with the environment (sea water and air). If no countermeasures are taken, there can be a leak on the side hull of the ship.

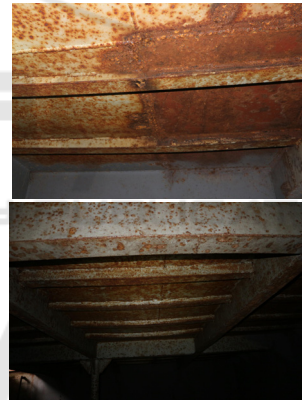
The next part of the vessel that has the potential to fail is the plate and main deck construction as shown in Figure 3. Corrosion in part is due to the lack of care and there are indications there is a crack that sea water and air can seep in until corrosion occurs on the inner stiffener.

Figure 3: Main deck plate.

Corrosion in this section results in the thinness of the main deck plate so that there is a possibility of a break due to the inability of the structure to withstand load loads.

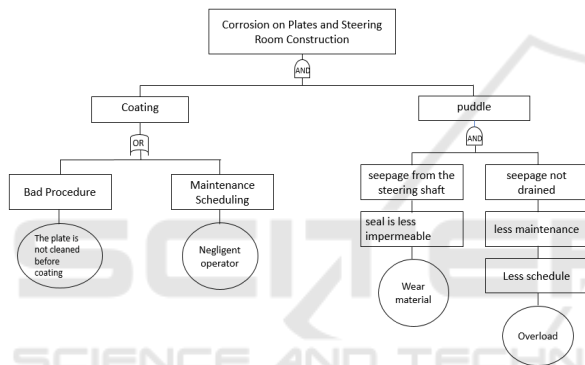
Figure 5: FTA of corrosion of the steering room construction

Figure 5 shows that the cause of the corrosion of the plate and construction in the steering room is the presence of stagnant water and problems with the coating. Stagnant water comes from seepage of water from the steering shaft which is not immediately drained. This water seepage occurs due to the seal of the rudder stock which is less impermeable due to the wear of the material.

Coating problems occur due to bad procedures or there are problems with maintenance scheduling. The bad procedure is that when the plates are being coated, sometimes the operators have not cleaned the remaining dirt on the plate first. While the problem in maintenance scheduling can occur due to negligence of officers who do not do the coating according to the coating schedule.

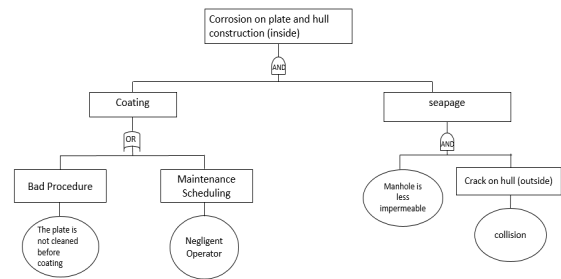
Figure 6: FTA of corrosion of the hull construction

The cause of corrosion in ship side hull construction is water seepage and coating problems (Figure 6). Seepage of water comes from manholes that are not impermeable and crack side hulls. The Crack can occur due to collisions when docked at the port.
