# Technical and Economic Analysis Repair of the Wooden Boat using Fiberglass Laminates on Fishing Boats in Lamongan District

Mohammad Sholikhhan Arif<sup>1 a</sup>, Heri Supomo, Hasanuddin, Sri Rejeki Wahyu Pribadi, Wing Hendro Prasetyo Akbar Putra, Dedi Budi Purwanto, Sufian Imam Wahidi, Ahmad Nasiruddin, and Chandra Ariesta

<sup>1</sup>*Department of Naval Architecture, Institut Teknologi Sepuluh Nopember, Indonesia*

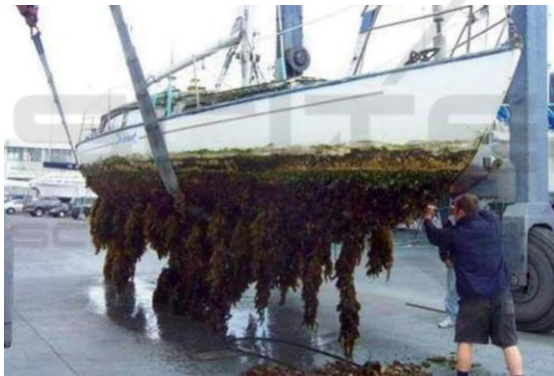
Marine growth is a various species of marine animals/plants that grow and colonize the surface of buildings/structures in the sea, where temperature, food/nutrition, pH (acidity) factors, and other environmental conditions are suitable for their growth. The growth of marine growth on the surface of this building may cause various problems. Marine growth that grows on wooden boats will cause the boat's weight to increase, causing additional resistance to the boat. In addition, marine growth on fishing boats will increase the boat's resistance when moving because the surface of the boat's skin becomes rough.

Figure 1: Marine growth.

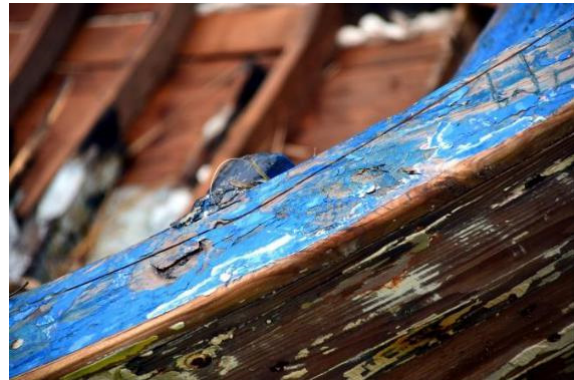
Wood Weathering occurs in the natural process of the wood itself, also caused by destructive marine animals such as moulds and barnacles attached to the body of the boat and microbes in the form of mould mildew. During this time, the process of drying/preservation of material carried out at the Boatyard naturally and takes up to one month, which will affect the strength of fishing vessels.

Weathering on wooden boats will cause damage to the boat hull in the form of leakage or reduced strength of the boat when receiving loads, both internal and external.

Figure 2: Wood weathering.

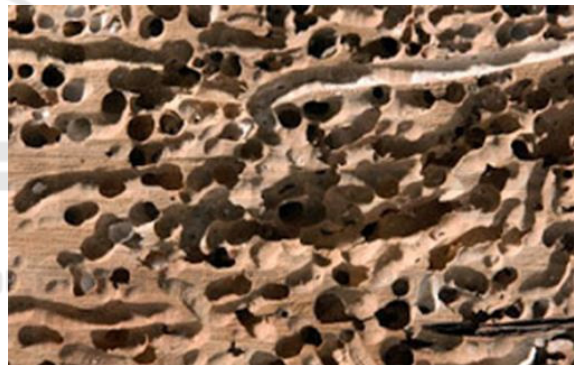
Leakage on the hull is one of the results of several previous events, such as the condition of weathered wood and the presence of sea animals that enter the construction of the wooden hull (Greene, 2016).

Figure 3: Leakage because of sea animals.

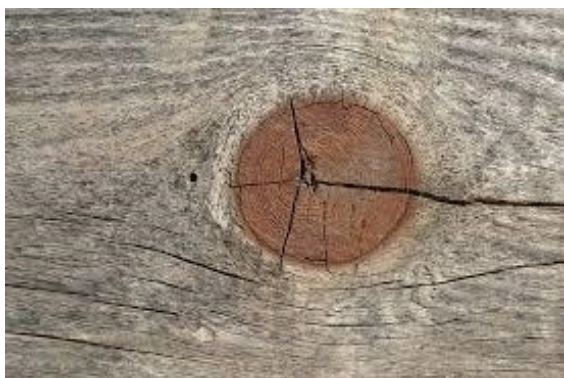
Crack damage on wooden boats occurs due to several possibilities such as collisions with objects, collisions on the hull of the boat and in the form of collisions with fellow boats or collisions between boats with objects in the water such as rocks, buoys, beams, logs, chunks of ice or collisions with other boats with objects in the water such as rocks, buoys, beams, logs, chunks of ice and others.

Collision with objects on the edge of the land, such as jetty and breakwater, occurs when they jutting into the water. Another possible cause of cracking is the damage associated with wave propagation to the hull of the boat due to the vibration of the propulsion engine and the other engines as well as the impact of the waves on the hull of both waves from the outside and waves that arise due to the spinning of the propeller engine and the other engines as the impact

Figure 4: Crack on the wooden boat.

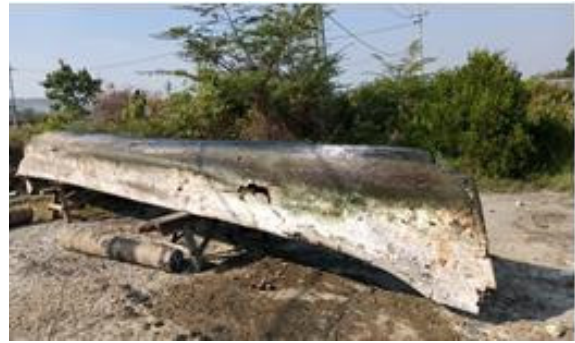
Figure 11: Boat drying process.

Wooden vessels to be laminated must be dried before starting to make repairs. The purpose of this drying is to avoid water content into the wood, which would damage the fiberglass layer, which will otherwise adhere tightly to the hull of the boat. Resin, fiberglass, and wood cannot bond effectively if exposed to water, even in minimal amounts (Sunardi, 2018).

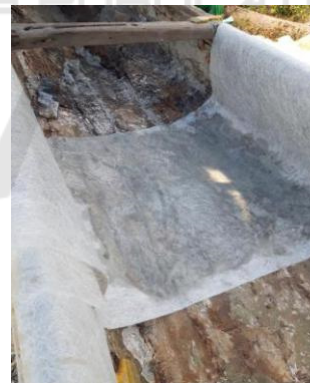
Figure 12: Installation of fiberglass fiber.

After the boat undergoes a drying and cleaning process, the next step of the boat is ready to be repaired by the fiberglass lamination method. Fiberglass laminates are used in 3 layers (Wood + CSM450 +WR600+ CSM300). This laminate will add a thickness of 5-10 mm.

The installation of fiberglass lamination will make the hull of the boat impermeable and not leak so that the boat will avoid the entry of seawater. Boat construction will also be stronger, and weathering in wood, which usually occurs due to seawater, will be avoided.

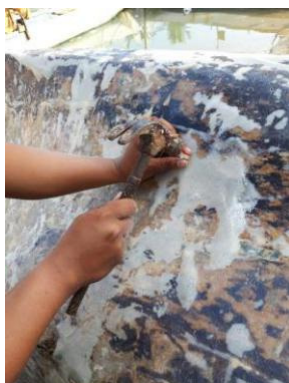
Figure 13: Nailing on the fiberglass layer.

Strengthening of the laminate with anti-rust nails measuring 3 cm at 20-30 cm. The purpose of nailing is to strengthen the fiberglass layer attached to the hull, so there is no possibility of the fiberglass separated layer from the hull.

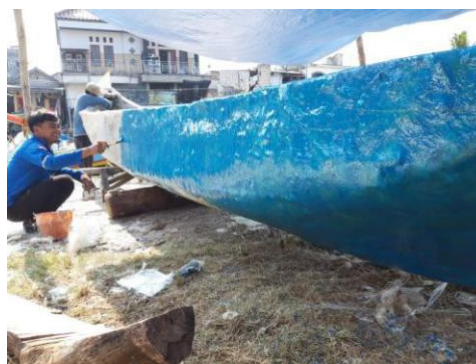
Figure 14: Painting on the hull of a boat.

After all the processes are done, the last step is to apply unique paint with colour pigments. This colour pigment is mixed with resin and additive to make the surface of the boat more glossy and not easy to get dirty. This paint can also avoid the sticking of sea animals or dirt that usually attached to the hull of the boat.

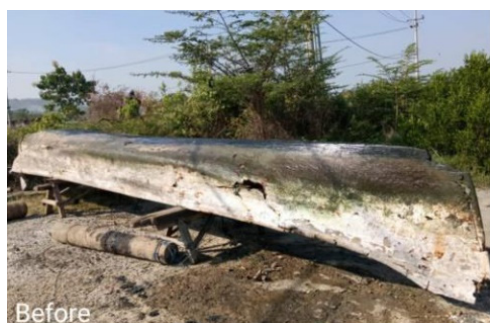
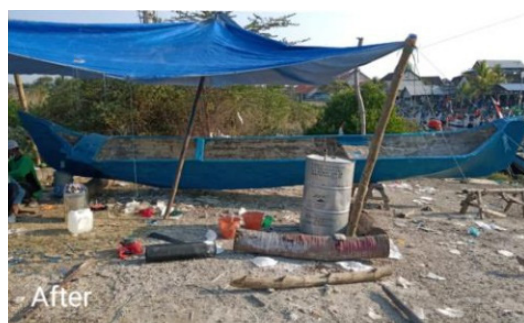
Figure 15: Boat Repair Before and After Results.

a. Before

b. After

1. Damages that occur on a wooden boat can be overcome by doing fiberglass lamination, which prevent wooden boats leaks.
2. Fiberglass laminated material, which marine animals and plants do not eat, allows the boat's life to be longer.
3. Facilitate the cleaning of the hull so that maintenance costs are lower compared to wooden boats.
