Mitigation of Seismic Risk in Urban Zones of Uzbekistan as Path for Strengthening of Sustainable Development of Region

Abstract: Population growth and active urbanization processes in Central Asia lead to seismic risk increasing in this region. Uzbekistan is most populated country in Central Asia. Along with the growth of civilian and earthquake engineering, many individual buildings remain in cities and also have trend for expansion. Sustainable development of region cannot be provided without safety resilience operating all civilian infrastructures. For mitigation of vulnerability of habitants during seismic event is the most important is housing safety. Assessment of stability for individual self-made, one and two storey residential structures are described in this issue. Measures for strengthening of such types of buildings are recommended in this issue.

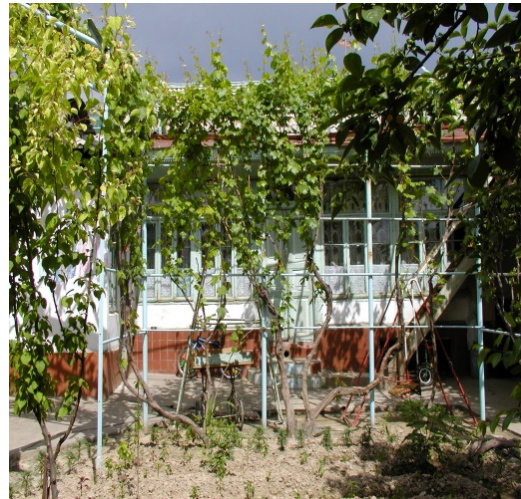
Figure 2: Front yard of house (photo by P. Burton).

Even nowadays most of the population lives in seismic dangerous territories of the republic in houses of individual construction, which are usually, one-storey buildings (two-storey if there are more than 4 rooms). The houses with dead longitudinal wall which looks at the street and longitudinal wall with door and window openings which makes front yard prevail (Figure 1, 2). That defends internal side from summer heat.

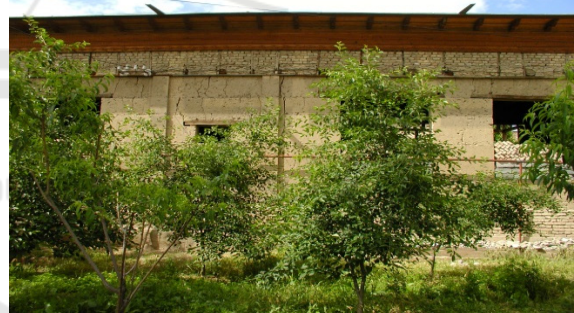
Figure 3: Incomplete houses from loam and bricks (photo by P. Burton).

Houses with loam and brick walls (“pakhsa”) (Figure 3).

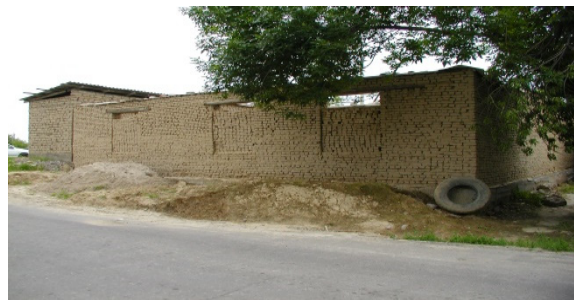
Figure 4: Incomplete houses from air bricks (photo by P. Burton).

Houses with walls from air brick (Figure 4).

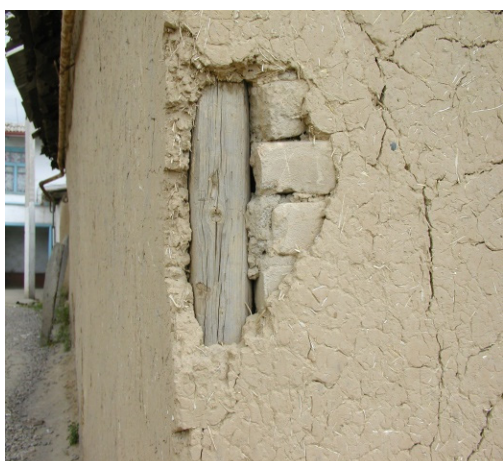
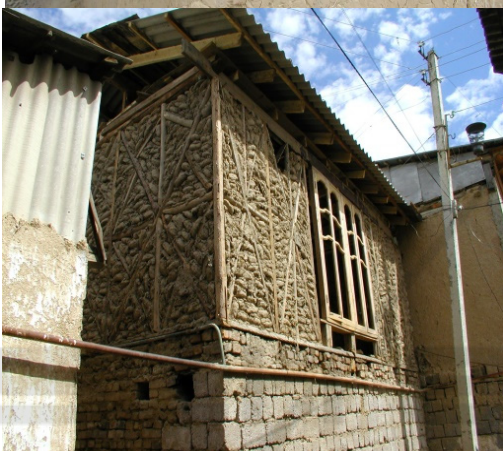
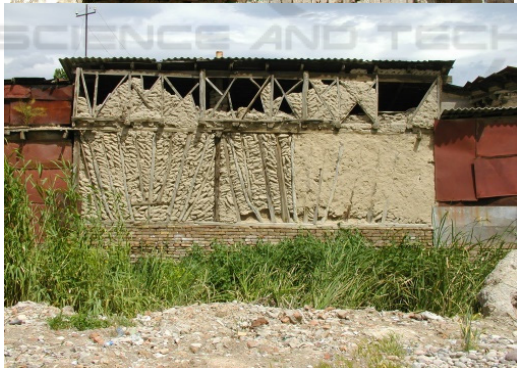
Figure 5: Incomplete houses with wooden frame filled with air bricks or guvala (“sinch”) (photo by P. Burton).

Houses with wooden frame that filled with air brick or guvala – clay lumps (“sinch”) (Figure 5).

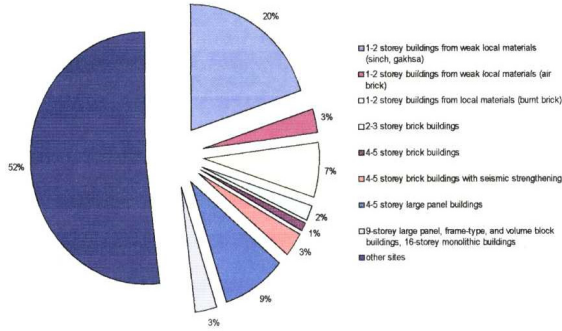
Figure 6: Various types of residential buildings.

hectares, from them apartments are on 15570 hectares (47,4%). According to the diagram of balance of the territory (Figure 6) part of individual buildings is more than 30% of the city territory, of which 20% are from air brick, 7 % are from burnt brick and 3% are from “sinch”/”pakhsa”.

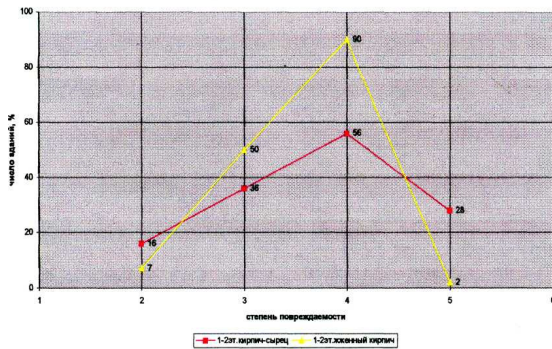
Figure 7: This caption has more than one line so it has to be set to justify.

The Figure 7 shows graphs of allocation of damageability level for 1-2 storey individual buildings during the earthquake in 1966.

From 682 inspected 1-2 storey houses of air bricks: 198 (28%) had fallen walls, 380 (56%) had huge cracks and fallen components and 104 (16%) had small cracks which were equal to 2.4 and 5 point

level of damage. Out of 1251 objects from air bricks, the cracks were in just 19 cases (1.4%). Big cracks and fall of components happened in 1126 objects (90%). In 88 objects perforated cracks vertical, horizontal and “X” shape (7.6%) were detected. The level of damage was grouped according to the next characteristics:

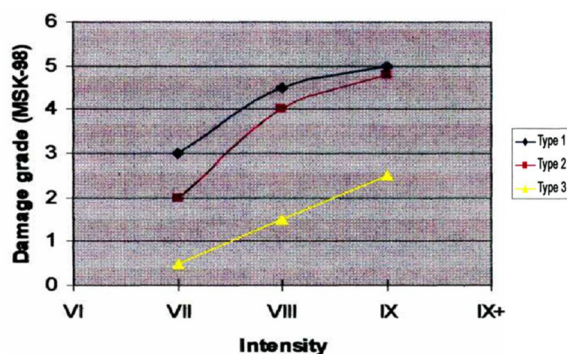
Figure 8: Vulnerability curves for residential houses from: 1 – Building of “pakhsa” type, 2 – Adobe buildings, 3 – Building with a wooden frame of a “sinch” type.

The vulnerability curve (Figure 8) based on the data on the Table 4 (Shamsiev, 1999, Akhmedov, 2006) are provided here.
